Yin, X, Lawrence, R, Maskell, D & Sun, C 2019, 'Assessment of straw degradation inside straw bale walls in severe cold region of China', Paper presented at 3rd International Conference on Bio-Based Building Materials, Belfast, 26/06/19 - 28/06/19.

ASSESSMENT OF STRAW DEGRADATION INSIDE STRAW BALE WALLS IN SEVERE COLD REGION OF CHINA

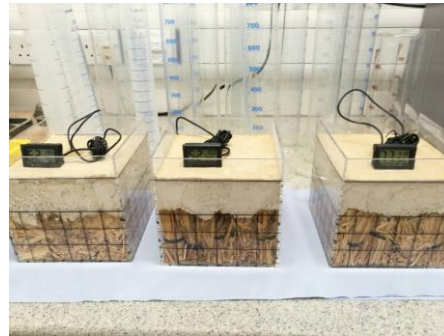
Figure 4. Section of walling construction in the degradation potential experiment

Straw bales and lime render were constructed in three transparent boxes to represent walling constructions of straw bale buildings (Figure 4). Both rice straw and wheat straw were used in different wall constructions. The straw was baled in small bundles and placed both parallel and perpendicular to the lime render to represent the laid flat stacking method and the laid on-edge stacking method in typical construction of straw bale buildings. A RH/T sensor was installed in the straw bundles in each specimen (Figure 5). The thickness of lime render was 50mm in the construction of specimen. The adjacent area between the lime render and the transparent boxes were sealed by wax to avoid direct pass of environmental RH to travel into the straw in the specimen. The transparent boxes of the walling constructions were labelled into small rectangle to identify possible area of straw degradation in the research.

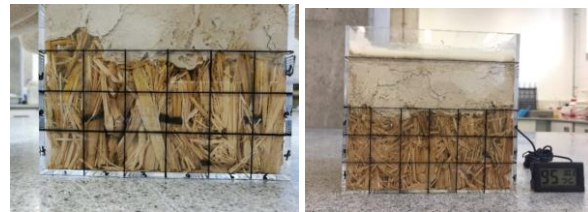
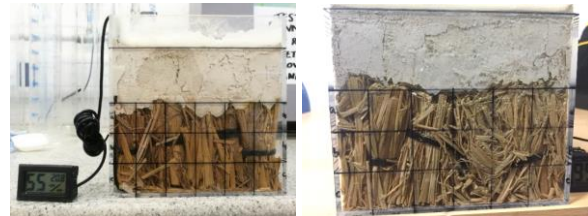
Figure 7. Specimen of rice straw with parallel placing before the degradation research (left) and after 12 weeks in climatic chamber (right)

Figure 8. Specimen of rice straw with perpendicular placing before the degradation research (left) and after 12 weeks in climatic chamber (right)

Figure 9. Specimen of wheat straw with perpendicular placing before the degradation research (left) and after 12 weeks in climatic chamber (right)

The visual checks of the specimens does not identify any recognisable straw degradation both in the experimental process and at the end of the experiments. Comparisons of the specimens of the straw status before experiment and after experiment are shown in Figure 7, Figure 8 and Figure 9. Existing research on sorption isotherm of straw have identified that straw would have serious degradation after more than 4 weeks exposure in the environment of 95% RH and 22°C (Carfrae, 2011, Lawrence et al., 2009). The straw in typical lime rendered construction becomes protected.

The experimental results show that straw does not exhibit signs of notable degradation in high humidity and high temperature environment. The property of low degradation potential of straw at high temperature has specific importance in building straw bale constructions in severe cold region of China. The potential self-builders of straw bale buildings are local farmers in the region. Because of extensive farming activities in spring and autumn, the group of self-builders are available for construction activities merely in summer. Due to the low degradation of straw in high RH and high temperature environment in the region, the straw bales in the buildings constructed in the summer months would have as little chance of degradation in other months in the climatic region.

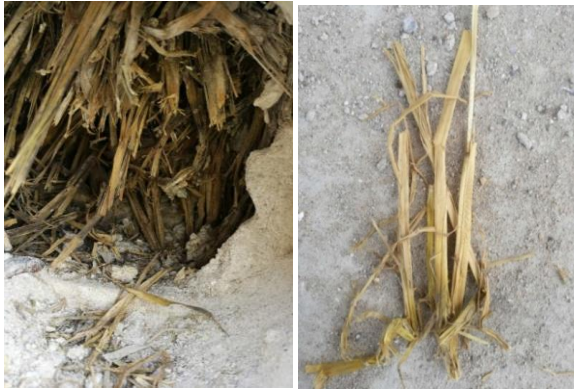
Figure 10. Opening of external render (left) and straw adjacent rendering layer (right) of low position of laid flat bale wall

To examine the straw conditions behind rendering layer, rendering layer of 8 positions (Table 1) were removed to expose the straw inside the bale walls in the second onsite visit after 11 months monitoring research on 19th June 2017. The straw was visually checked onsite. There was limited degradation of straw at the interface between straw bales and external rendering for all opened positions (Figure 10). The degradation appears on the interface of lime render and straw bales and penetrated 2-3 cm deep into the straw bales. The straw behind the interface remains golden colour inside the walls. The site visit confirms that the straw was in good condition inside the straw bale walls for one year. Unlike

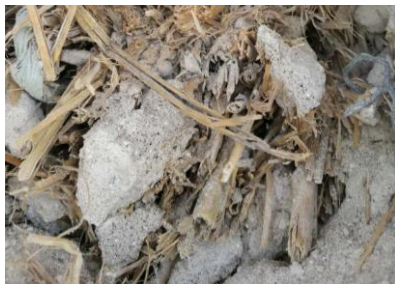
Figure 11. Mixture of straw and lime stucco outside the high position of laid flat bale wall

the limited straw degradation on the interface between straw bales and the lime render layers, the straw was in good condition with mixture of lime render (Figure 11).

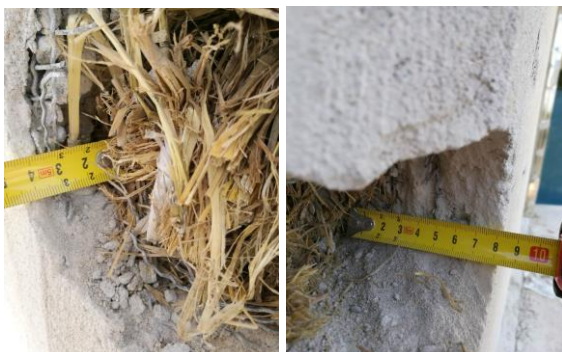
Figure 12. Straw conditions behind opening locations with thin rendering thickness (left) and thick rendering thickness (right)

The thickness of lime rendering varies significantly from the design thickness (Figure 12). The thickness variations of lime rendering was between 40mm to 105mm in the experimental building (Table1). The thicker lime rendering layers may provide more moisture buffering to straw bales and introduce more initial moisture in the straw bales at the drying stage of lime rendering. The bales behind the thicker lime rendering would have higher initial moisture content and have longer drying period than the one behind thinner lime rendering. However, the thicker lime render layers do not have significant effect on straw degradation from visually inspection.

During the onsite visit, the straw outside the high position of on-edge bale wall show insignificant decolourisation and no notable mould growth are identified on the straw surface by visual inspection through the drilled opening outside the monitoring location (Figure 12). Even though straw degradation is identified behind the render layer outside the low position of laid flat bale wall, the situations are not as severe as the prediction of the isopleth model. The limited straw degradation only appears on the surface of straw bale stacking and the straw remain unchanged inside the bales.
